July 27, 2011

C10147-011

SILVERTON VILLAGE GALLERY BUILDING ASSESSMENT

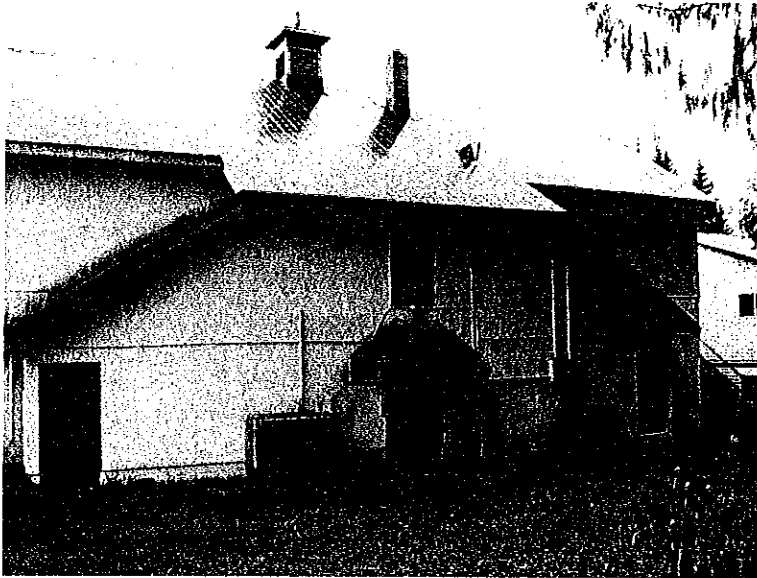
Multiple locations on the roof and wall systems over the entrances at the rear of the building (Figure 1) show signs of water damage (Figures 2-4). The stucco is stained and is supporting growth of mold and moss due to the high moisture content.

Figure 1: Rear of building.

Leonard Casley, Village of Silverton representative, opened up the interior walls, which back the areas of concern noted in Figures 1-4. He reported to WSA that the original wall planking has severe dry rot, from moisture penetration at the locations observed. He also reported that the wood stud framing did not show signs of rot at these locations.

It is recommended to install flashing at the noted locations of moisture penetration at the rear of the building back wall to prevent moisture from contacting the stucco and penetrating into the wood framing.

It is recommended to install flashing at the noted locations of moisture penetration at the rear of the building back wall to prevent snow, ice, and rain moisture from contacting the stucco and penetrating to the wood framing.

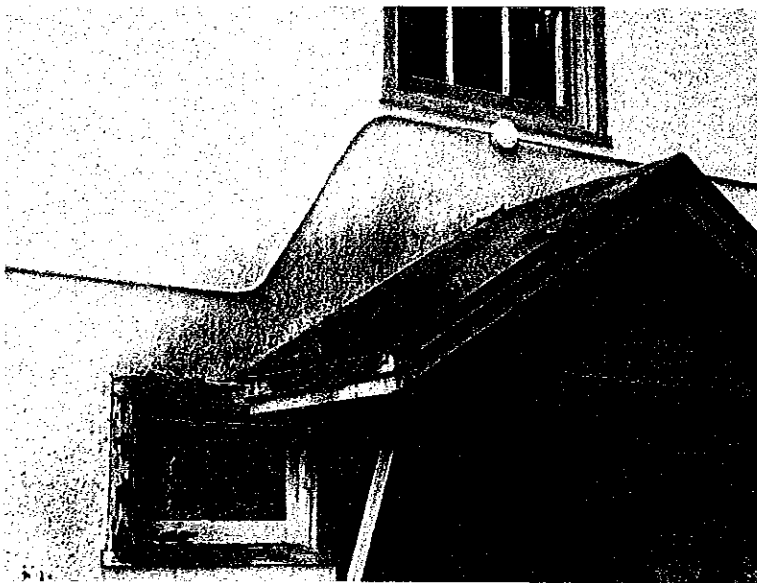
Figure 2: Rear centre entrance left side.

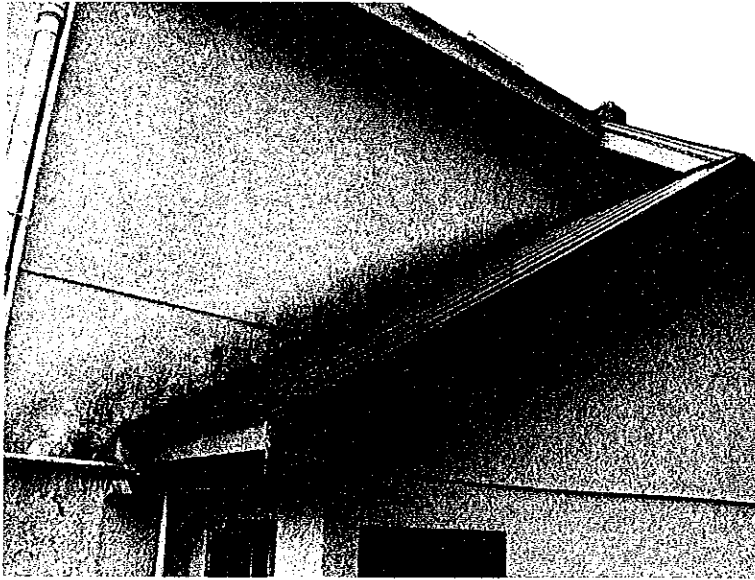
Figure 3: Eaves over rear left entrance.

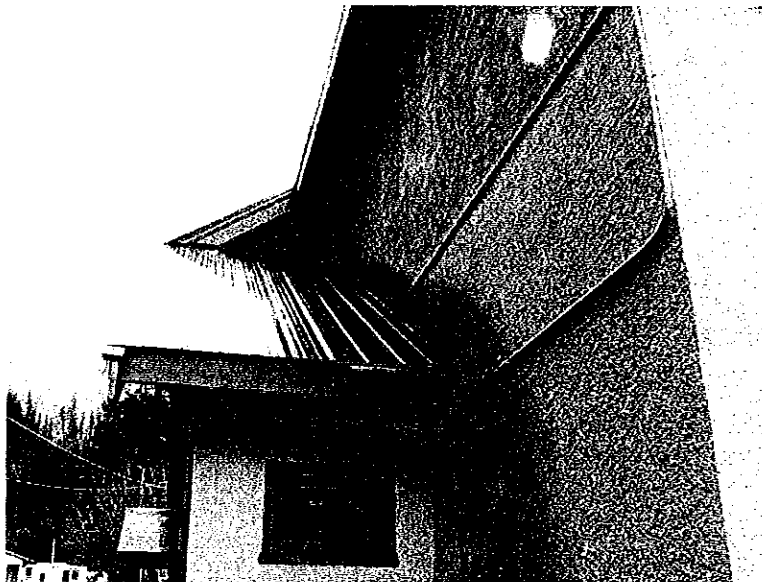
Figure 4: Eaves over rear right entrance.

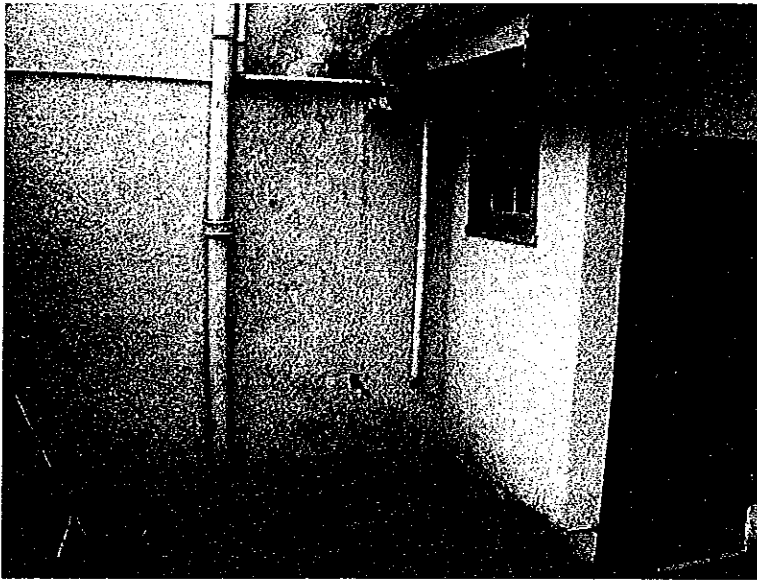
The wood wall framing on the rear wall extends to within 6" of the finished grade at the rear of the building. This is a situation that will tend to encourage moisture damage in the wall framing.

Figure 5: Grade beside rear left entrance.

It is recommended to regrade this and other locations as required to ensure that there is a minimum 6" of exposed foundation between the finished grade and the wood framing.

It is recommended to adjust the finished grade around the building envelope to ensure that there is 6" of exposed foundation / concrete between the finished grade and the wood framing and posts.

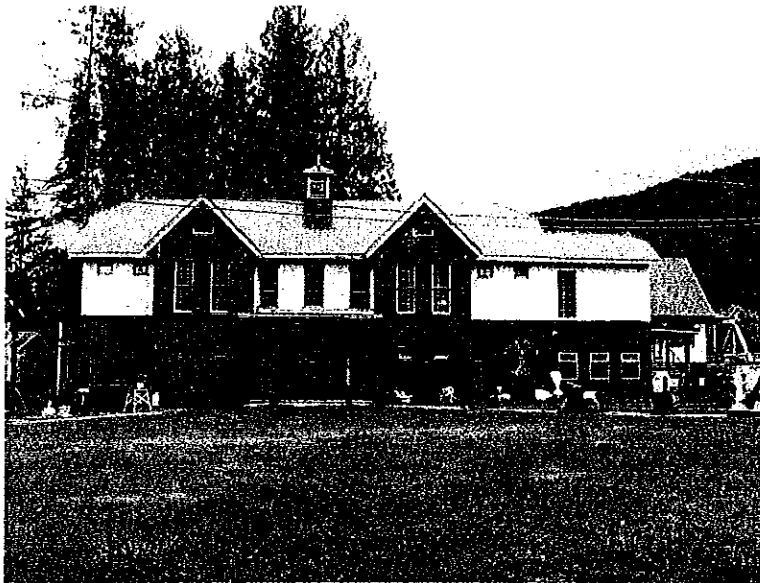
There is a small roof which extends over the front entrance of the building (Figure 8).

Figure 8: Building front entrance.

A further concern is that the front entrance roof is flat, so that snow is not shed from the structure. This snow buildup allows moisture to penetrate into the window framing above this roof, which then runs down the inside of the wall system (Figure 9). The affected window sills are completely rotted and have been patched with a temporary flashing. The original wall planking is severely rotted and the wall studs also show signs of water damage.

It is recommended that the front entrance be removed and reconstructed to match the original entrance (Figure 11). Restoring the original entrance feature would shed snow away from the upper story windows and deposit it on the ground. With additional new flashing, the water penetration at this location is likely to cease. It is recommended that an investigation into the main floor wall system below this location be completed to ensure that the lower studs and wall planking are not rotting due to the water intrusion from above.

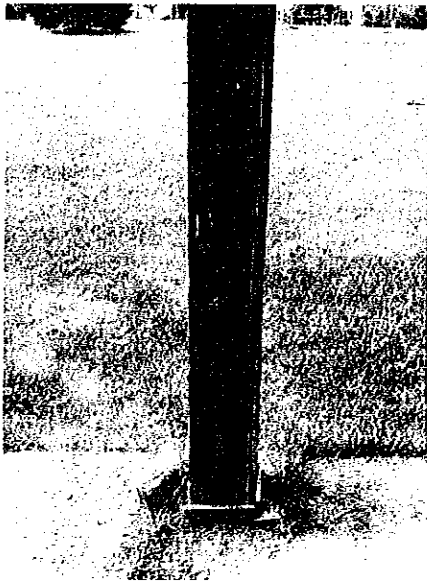
The posts supporting this entrance roof show signs of weathering and moisture damage (Figure 10).

Figure 10: Front entrance post.

It is recommended that this system be modified (e.g. with a small concrete column) such that the bottom of the post rests a minimum 6" above the finished grade.

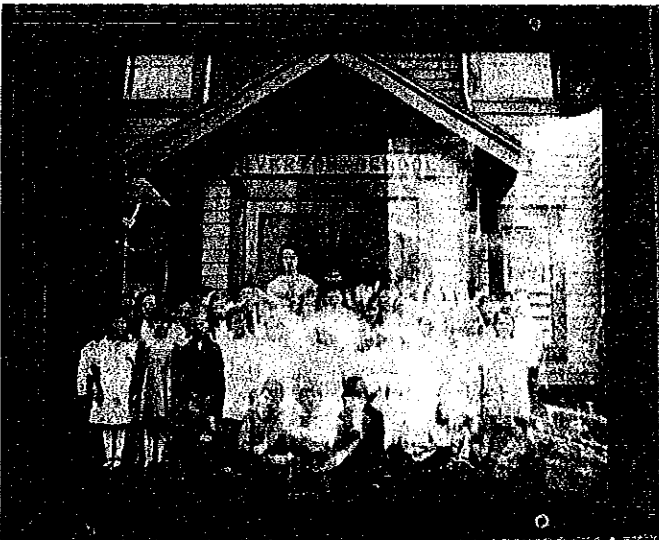
Figure 11: Historical image showing original front entrance covered roof.
