## **VILLAGE OF SILVERTON**

Regular Open Council Meeting Agenda

**MINISTRY OF FORESTS: POST-WILDFIRE NATURAL HAZARD RISK ANALYSIS  
NEMO CREEK - LEVEL 2 RECONNAISSANCE REPORT**

<b>FIRE NUMBER: N51103 Nemo Creek and N51228</b>	<b>FIRE YEAR: 2024</b>	<b>DATE OF REPORT:</b> December 19, 2024	
<b>AUTHOR:</b> Sarah Crookshanks, P.Geo., Ministry of Forests			
<b>REPORT PREPARED FOR:</b> Southeast Fire Centre, District Manager			
<b>FIRE SIZE, LOCATION, AND LAND OWNERSHIP:</b> 5980 ha on provincially managed public lands on the west shore of Slokan Lake (N51103). This fire was mostly contained within Valhalla Provincial Park. An additional 234 ha was burned within Valhalla Provincial Park in the Nemo Creek drainage (N51228).			
<b>VALUES AT RISK:</b>			
<ol style="list-style-type: none"> <li>1. Private residences</li> <li>2. BC Parks campsites</li> <li>3. Domestic surface water quality</li> </ol>			
<b>WATERSHEDS AFFECTED</b>	<b>TOTAL AREA</b>	<b>AREA BURNED</b>	<b>BURN SEVERITY</b> (% of watershed area)
<i>Wee Sandy Creek</i>	5543 ha	970 ha (17%)	3% High, 7% Moderate
<i>Sharp Creek</i>	1291 ha	117 ha (9%)	0.5% High, 4% Moderate

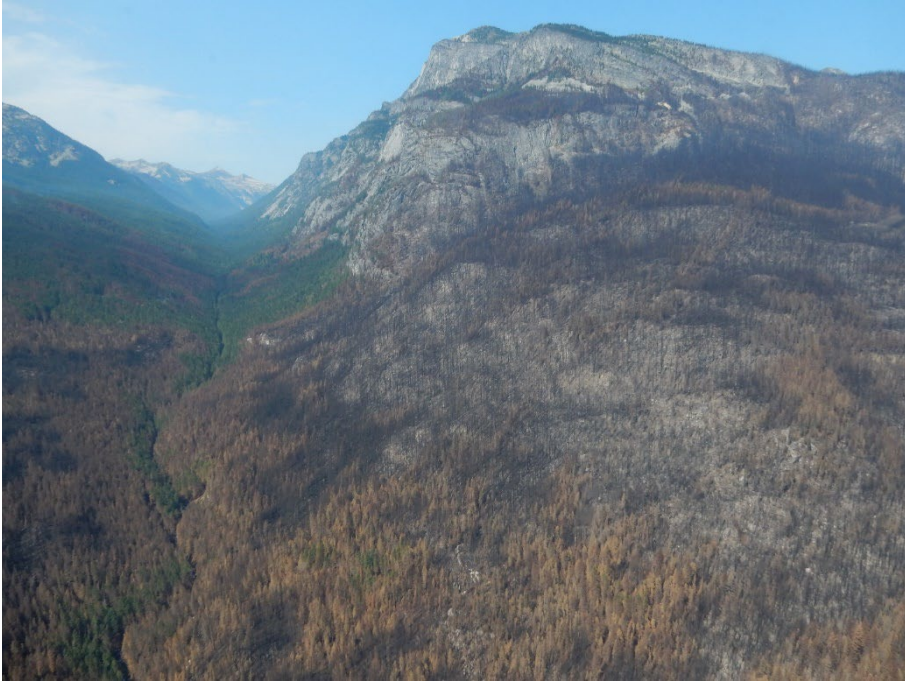
*Figure 2. Looking upstream at the Nemo Creek valley.*

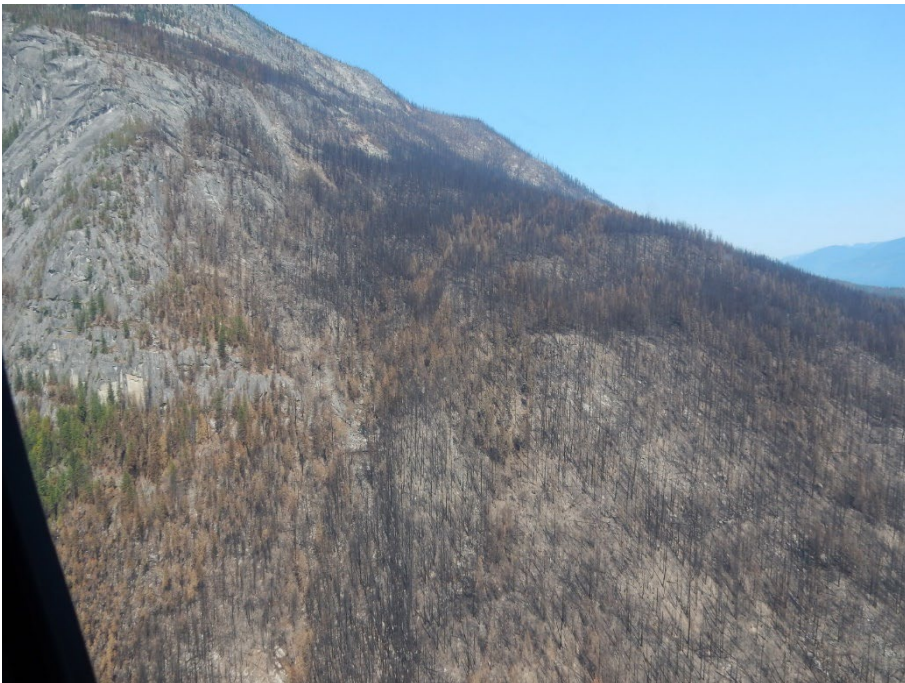
*Figure 3. Potentially debris-flow prone tributary to Nemo Creek.*

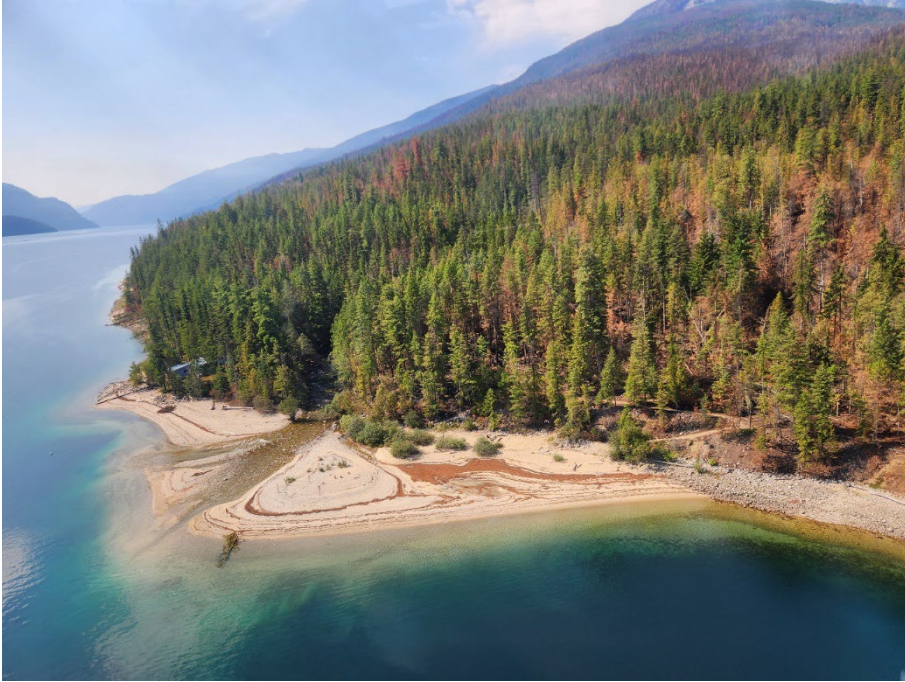
*Figure 4. Nemo Creek fan (Photo: Ryan Williams, SNT Geotechnical)*

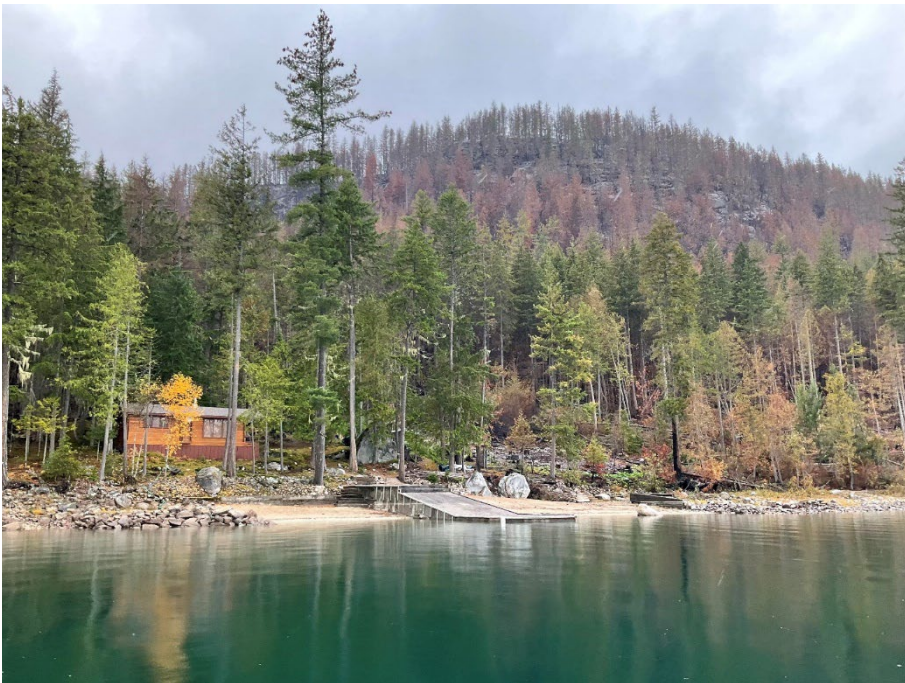
*Figure 5. Private cabins below a rock bluff north of Hoben Creek.*

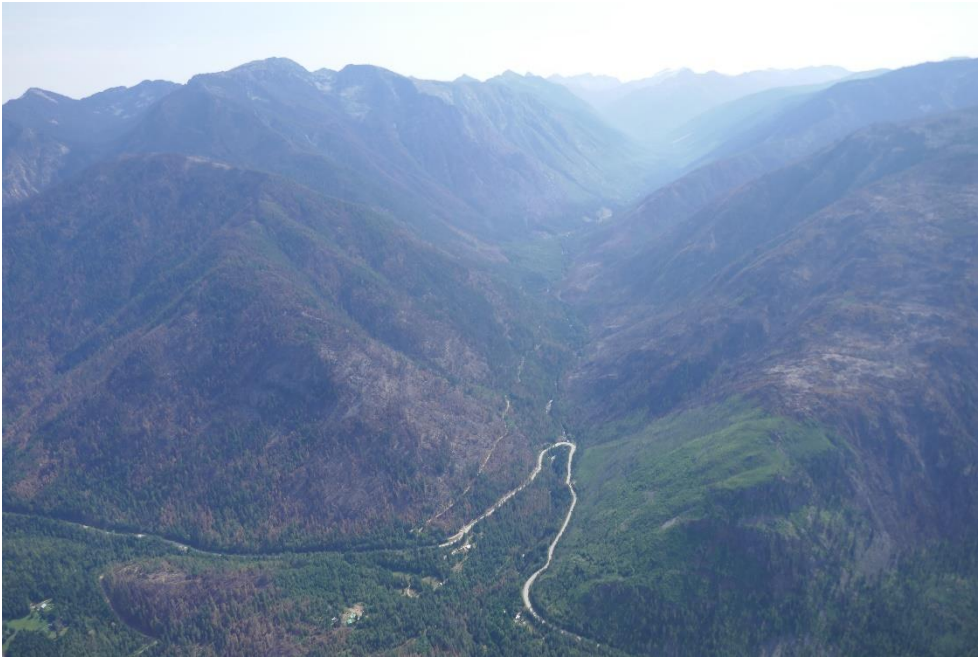
Figure 2. Enterprise Creek (Photo: T. Giles, SNT Geotechnical).

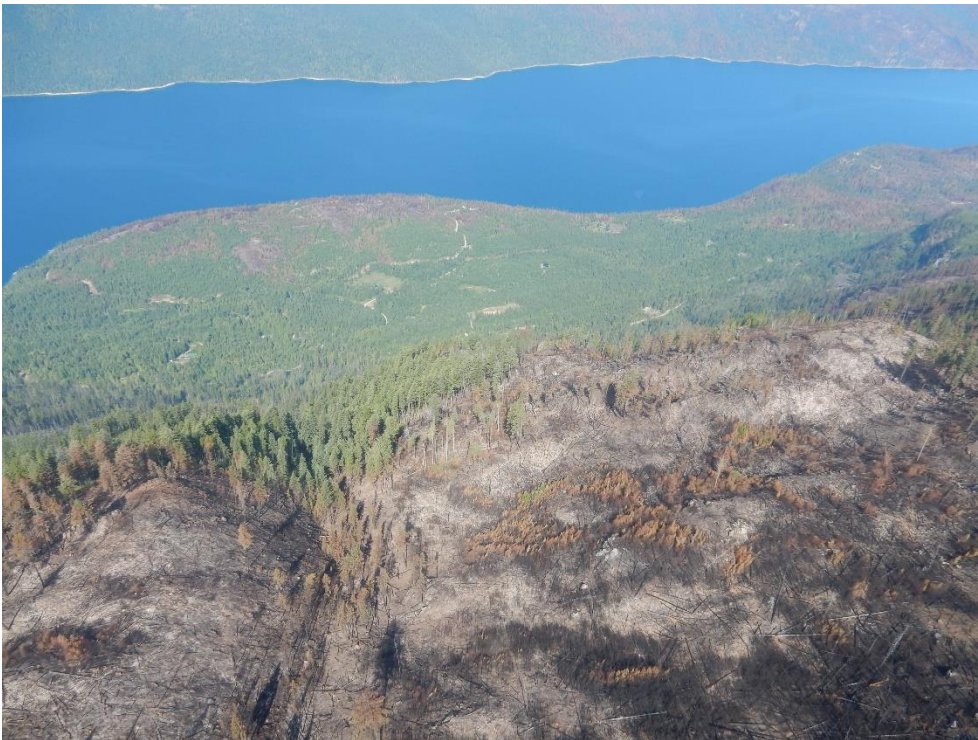
Figure 3. Headwaters of Cory Creek.

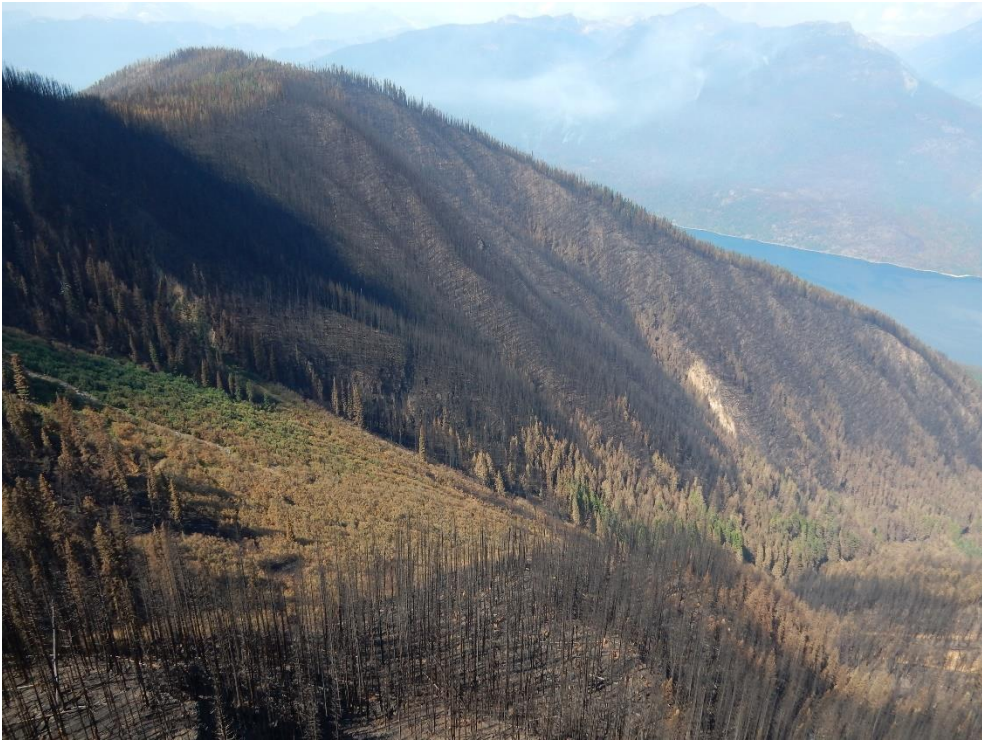
*Figure 4. Photo of high burn severity in the Aylwin Creek watershed.*

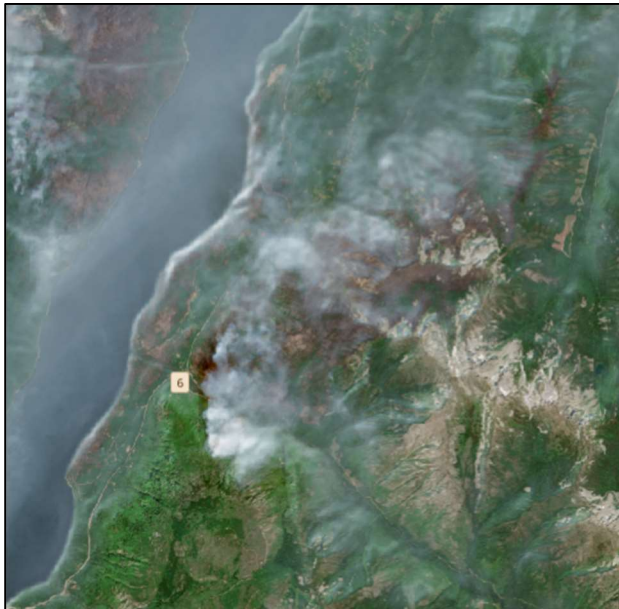
**Photo 1:** Sentinel-2 L2A Satellite imagery from August 1; the Fire is crossing the Enterprise Creek valley.

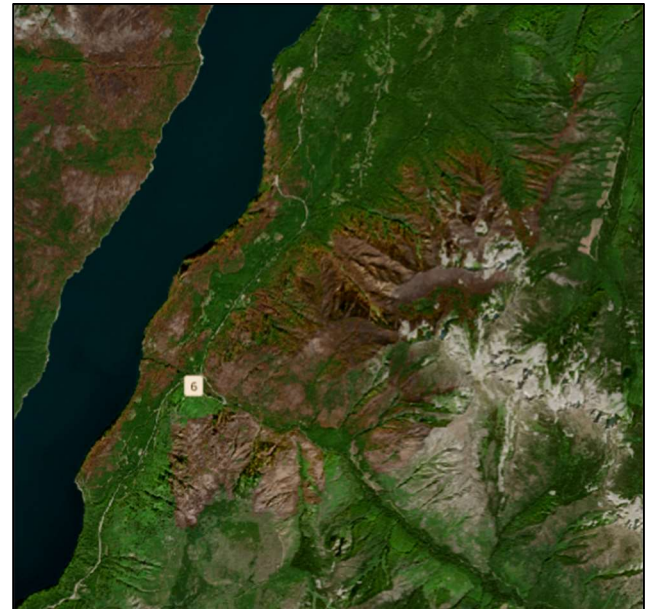
**Photo 2:** Sentinel-2 L2A Satellite imagery from August 31; the Fire appears to be out.

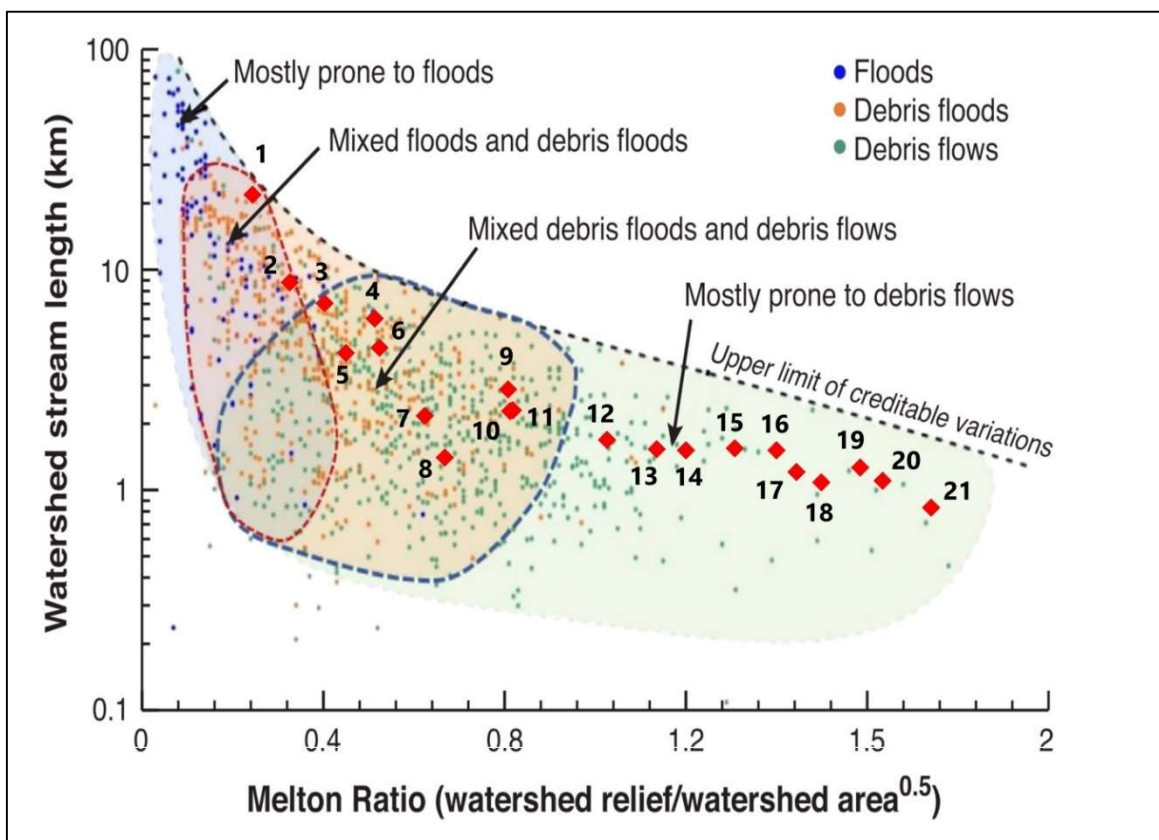
Church and Jakob (2020) use a different metric to differentiate between hydrogeomorphic processes; they plotted the Melton ratio versus stream length for a large dataset from watersheds across BC and Alberta (Figure 6). Due to greater relief along shorter streams, the Melton ratios in steep face unit streams have higher Melton ratios; these are shaded in green in Table 6. All of the small face unit streams plot in the “*Mostly prone to debris flows*” zone. The mid-sized watersheds, shaded orange in Table 6, have lower Melton ratios and plot in the “*Mixed debris floods and debris flows*” zone. Enterprise and Maurier Creeks have large watersheds with long moderate-gradient streams that plot in the “*Mixed floods and debris floods*” zone. None of the creeks in the Fire plot in the “*Mostly prone to floods*” zone as the physiography of the region is typically mountainous with steep slopes.

**Figure 6:** The Fire creeks plotted on a figure of the steep creek processes as a function of the Melton ratio and stream length, from Church and Jakob (2020<sup>25</sup>). The numbers refer to the watersheds in Table 6.

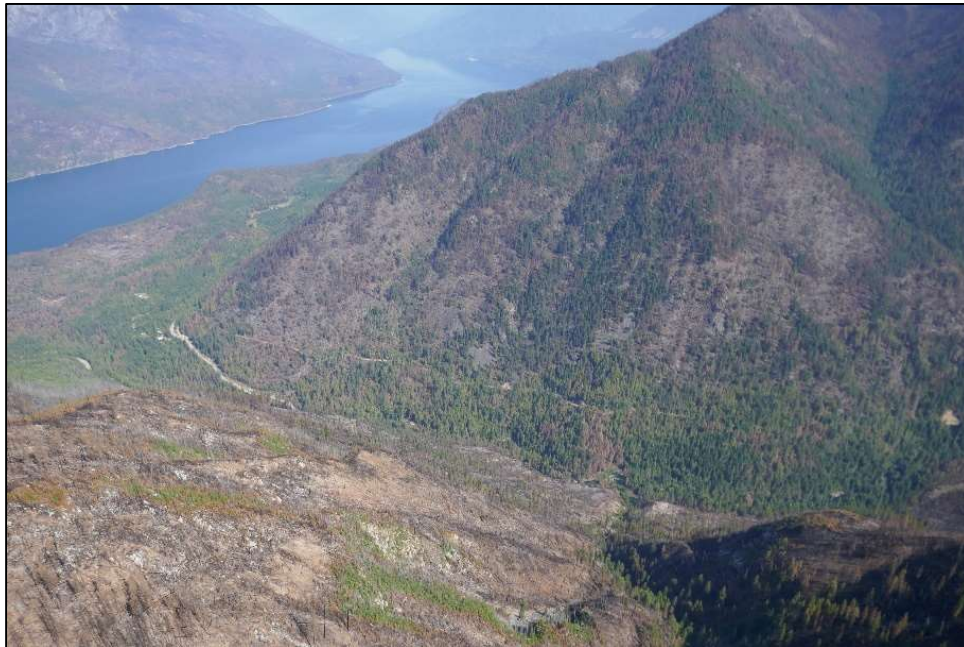
**Photo 4:** View of the south-facing slope of Enterprise Creek which has mostly mixed moderate and low VBS (see Map 1). The Highway can be seen at left, Enterprise Creek FSR cuts across the lower portion of the slope in the area of mixed low VBS and unburned forest.

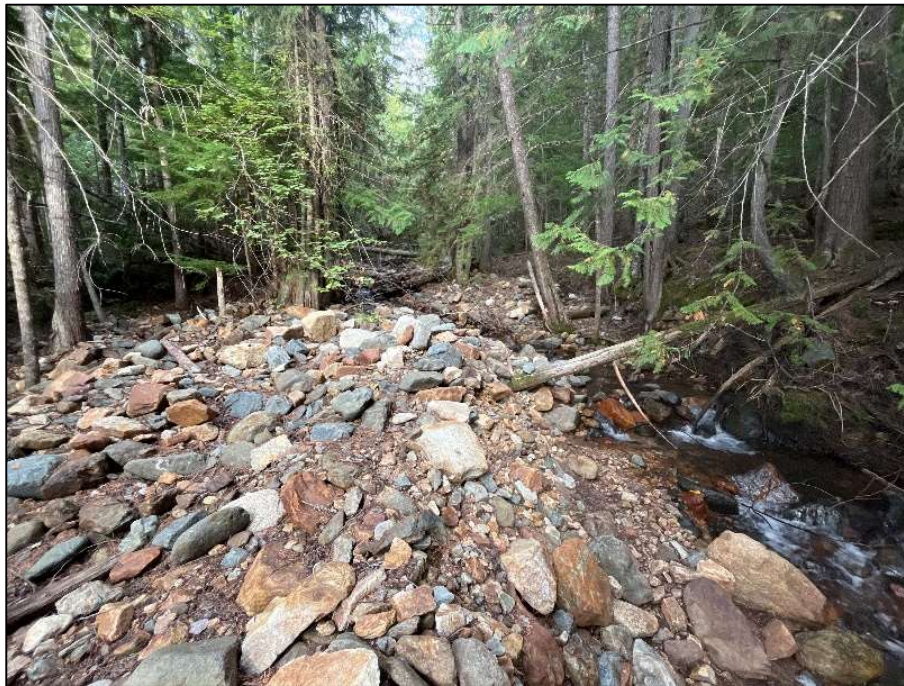
**Photo 9:** View upstream along Aylwin Creek immediately upstream from the Highway crossing (a 2000 mm steel plate culvert). The creek is filled with coarse cobble and boulder gravels and large wood pieces. Streamflow is diverting around the elevated sediment accumulations (aggradation).

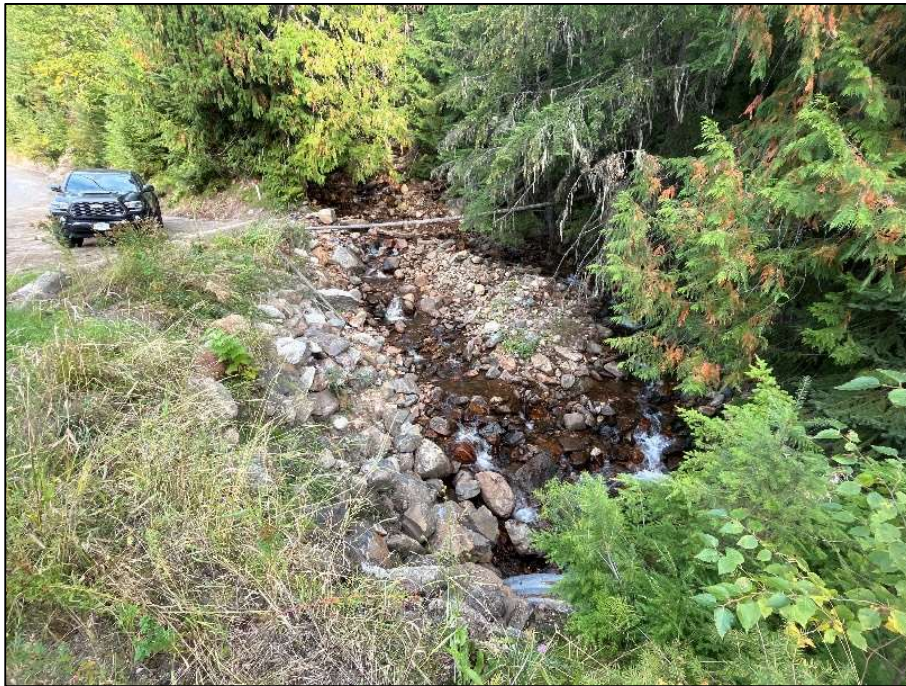
**Photo 10:** Looking upstream along Aylwin Creek from the Highway crossing (Field Observation Site K8). Note the low freeboard on the left side of the image where avulsion of the creek could easily occur and flow could be diverted onto the Highway.

**Photo 26:** Construction of a wide channel through an armoured catch basin with a trash rack at the culvert inlet, such as shown in this image, may be a suitable solution at the highway crossing of Aylwin Creek.

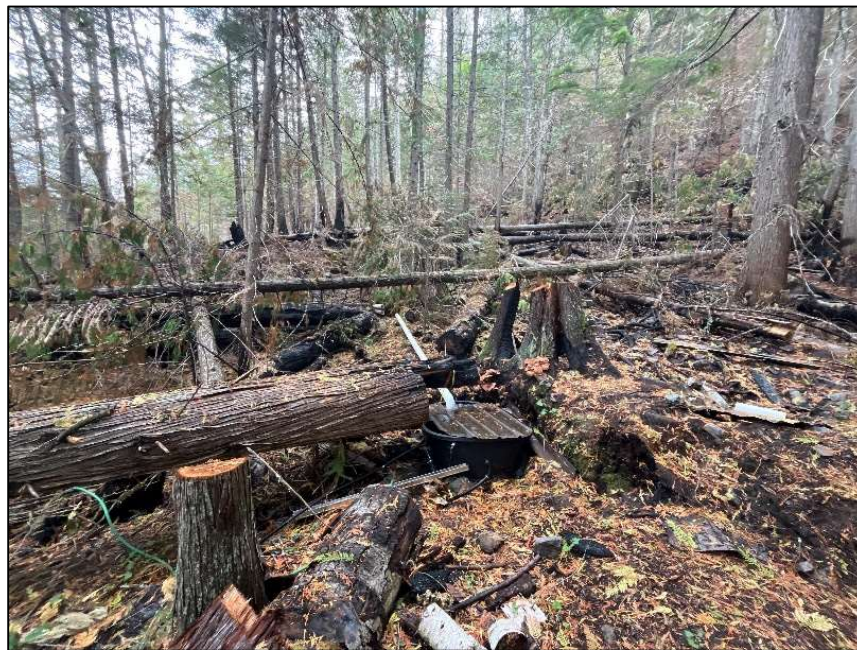
**Photo 11:** Cabin Creek is a small creek in a shallow swale on the lower slope above the Highway (Field Observation Site K20).

sediment lobes indicative of debris flow activity. The creek observed within this watershed is small and flows through a moderately confined swale on the moderately to gently graded lower slopes (Photo 11).

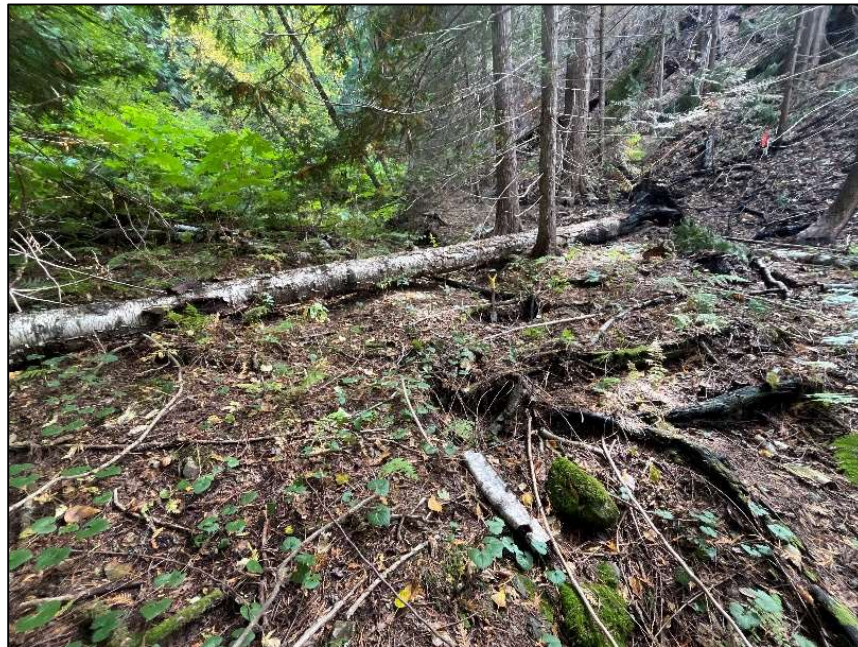
**Photo 12:** View upstream along Congo Creek on the upper alluvial fan (Field Observation Site K34). Congo Creek was a small creek with very limited flow at the time of observation, but there is a narrow channel armoured with coarse cobbles and boulders.

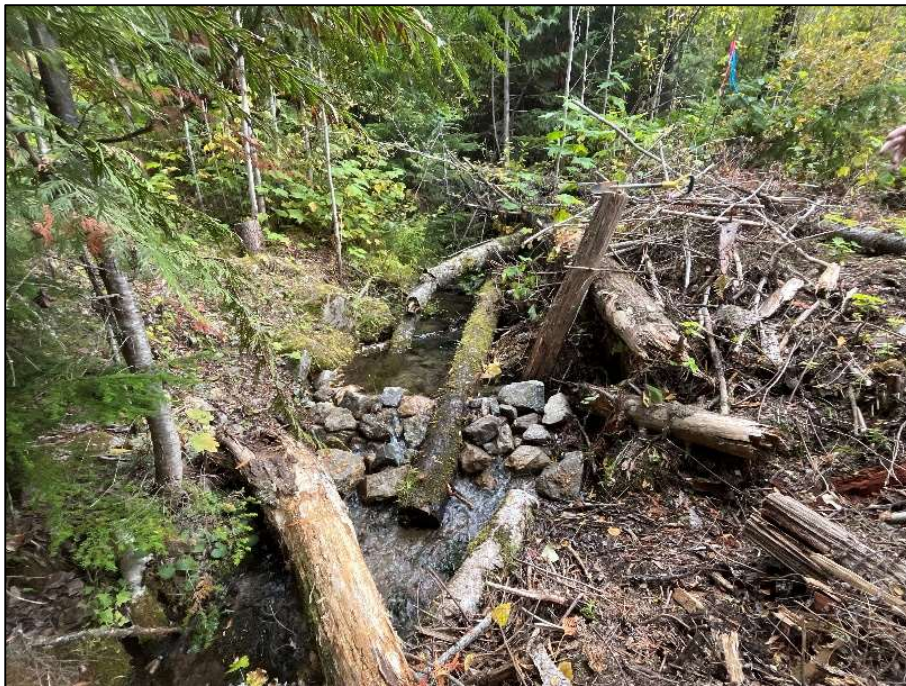
**Photo 14:** Cory North Creek along the fireguard (Field Observation Site K55).

Cory North Creek is a small tributary watershed within the Cory Main Creek watershed. The watershed is 1.10 km<sup>2</sup> in size, has a Melton ratio of 1.13 and a length of 2.600 km. This steep tributary watershed is considered to be able to initiate and transport post wildfire debris flows. The creek observed within this watershed has steady flow and is in a confined draw on the moderately graded lower slopes (Photo 14). The recently constructed fireguard reached this creek but did not cross it and the creek was not altered during the firefighting.

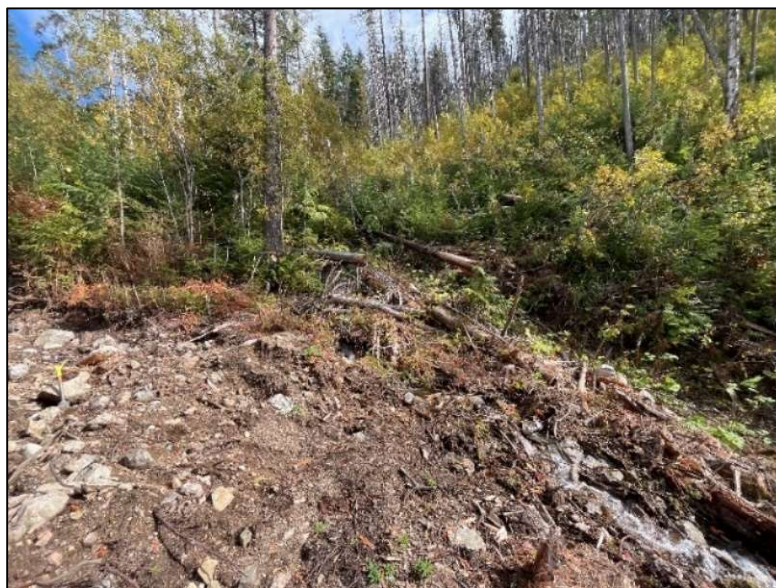
**Photo 15:** The south branch of Cory South Creek crossing the fireguard constructed across the upper portion of the alluvial fan (Field Observation Site K53).

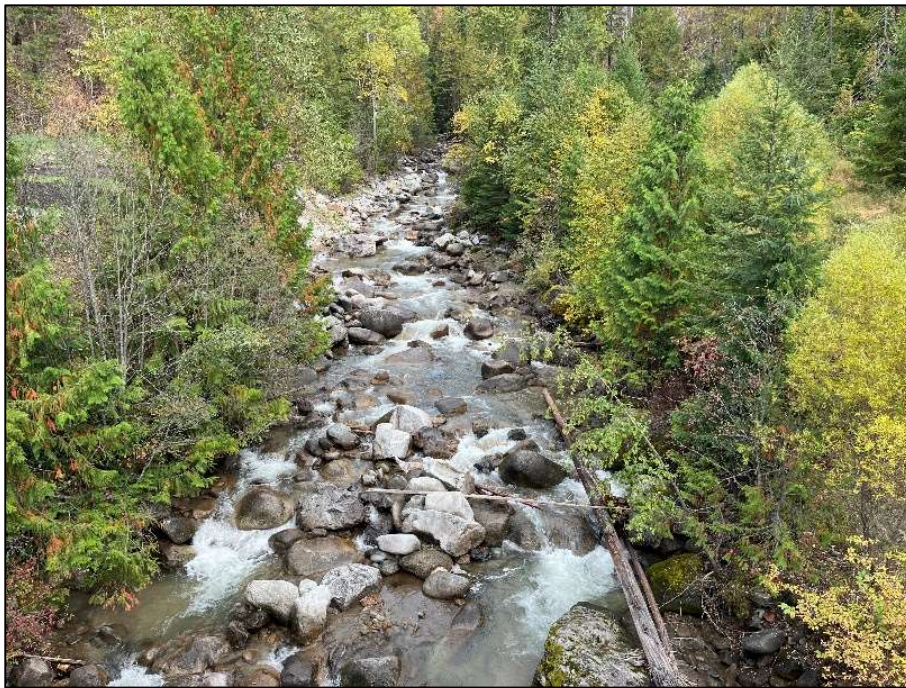
**Photo 16:** View looking upstream along Enterprise Creek from the Highway crossing (Field Observation Site K43).

Enterprise Creek is a large watershed with numerous steeply sloped tributaries leading down to the mainstem channel (Photo 16). The watershed is 73.00 km<sup>2</sup> in size, has a Melton ratio of 0.24 and a length of 19.500 km. The main watershed is considered to be a flood watershed. Several steep tributary watersheds within the watershed burned, but these are upstream of the Highway crossing. Enterprise Gully is a very steep watershed located immediately upslope of the Highway on the south side of the crossing and is discussed individually below.

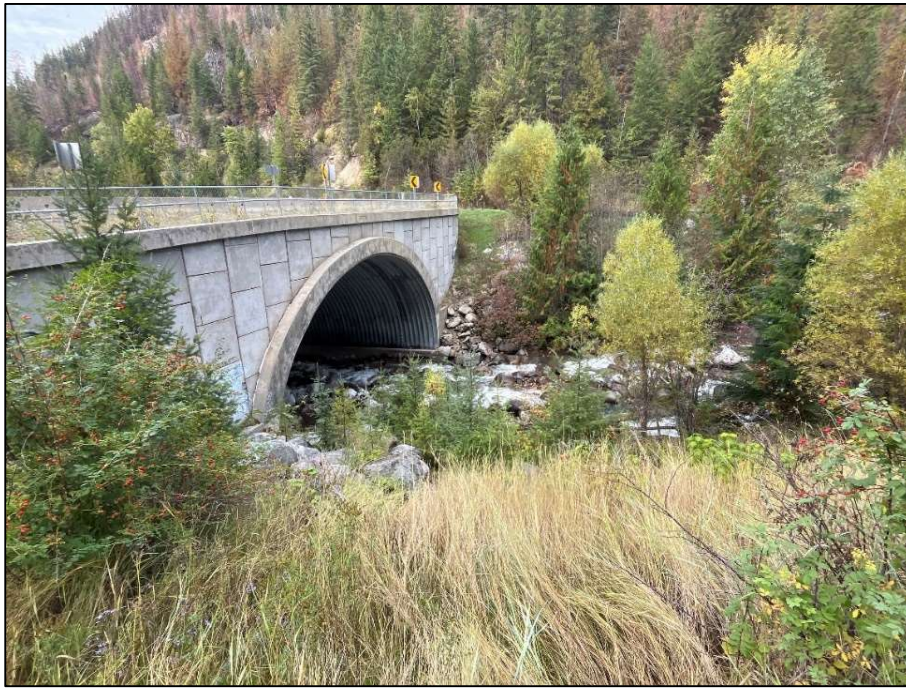
**Photo 17:** View of the inlet of the large arch culvert on Enterprise Creek at the Highway crossing (Field Observation Site K43).

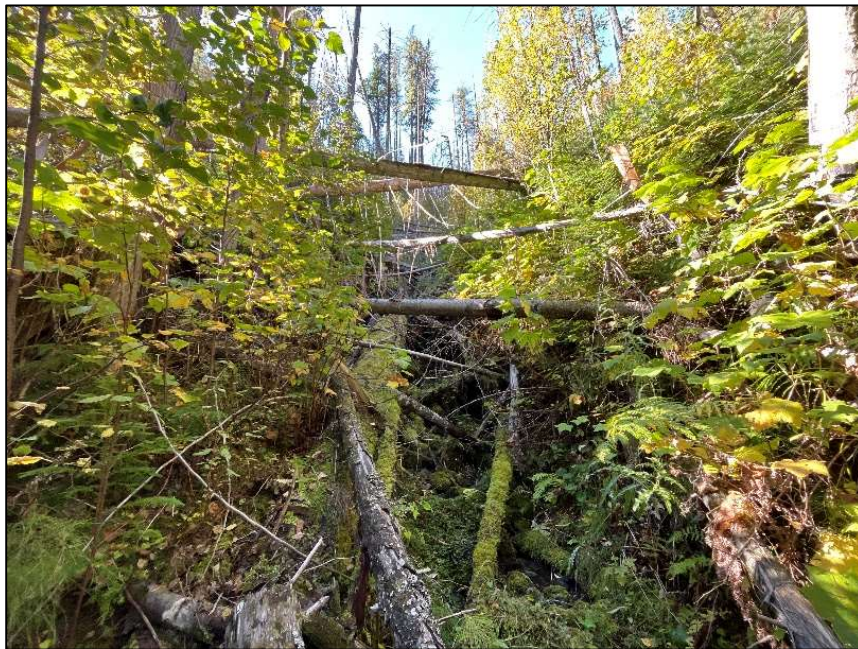
**Photo 19:** View upslope along Enterprise Gully (Field Observation Site K44) on the lower slope above the Highway. The channel has a steep gradient (35-45%), is deeply incised (3-5 m deep) and infilled with large woody debris.

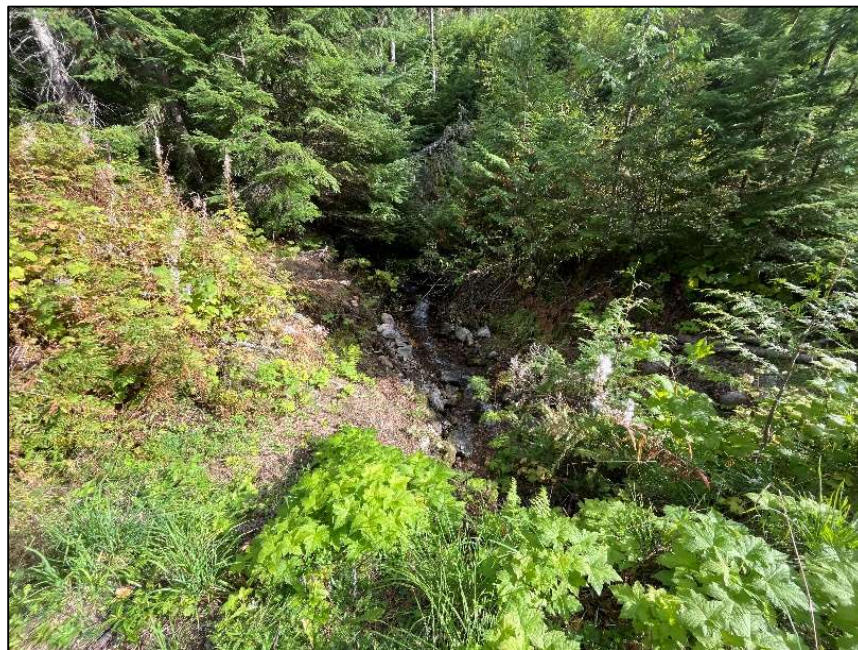
**Photo 20:** View upstream along Fingland Creek. The creek is contained in a deep, low gradient draw as it reaches RMR at Field Observation Site K3.

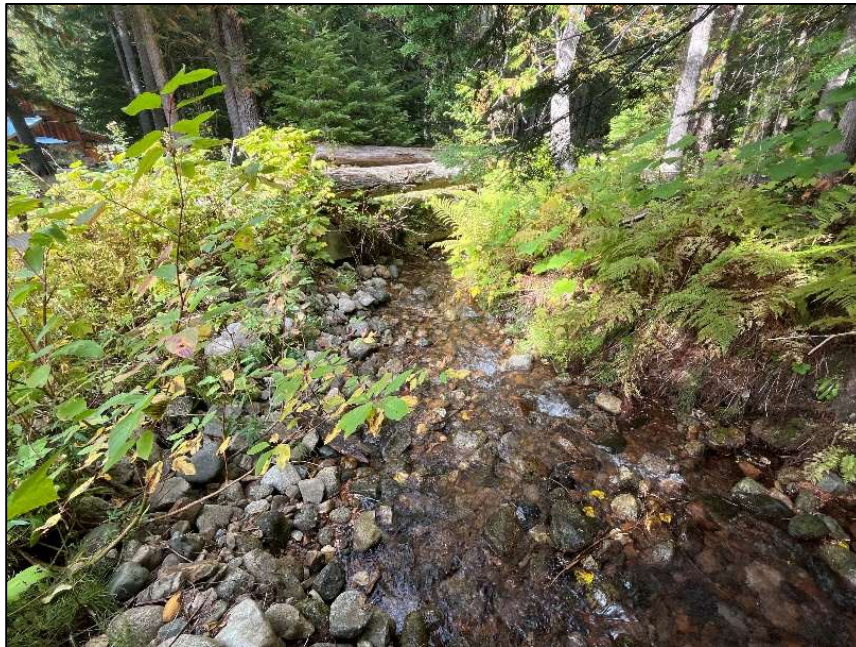
**Photo 21:** View downstream along Fingland Creek from the access road to 8473 RMR (Field Observation Site K4). The creek has a low gradient and is contained in a shallow swale. The residence, visible at upper left, is located 50 m from the creek on a flat bench and is potentially vulnerable to flooding or creek avulsion.

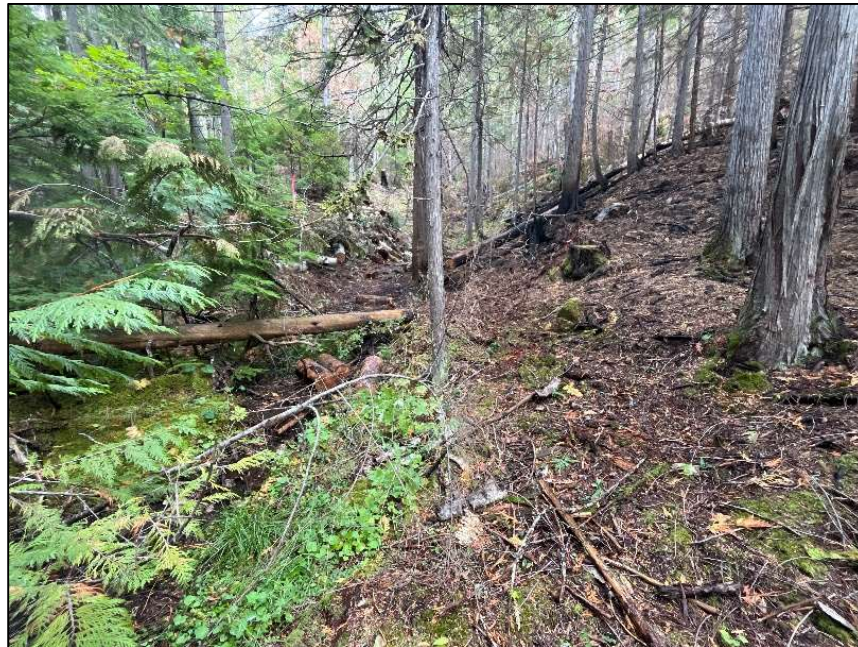
**Photo 22:** Harte Creek is a small creek in a shallow swale on the lower slope above the Highway (Field Observation Site K19).

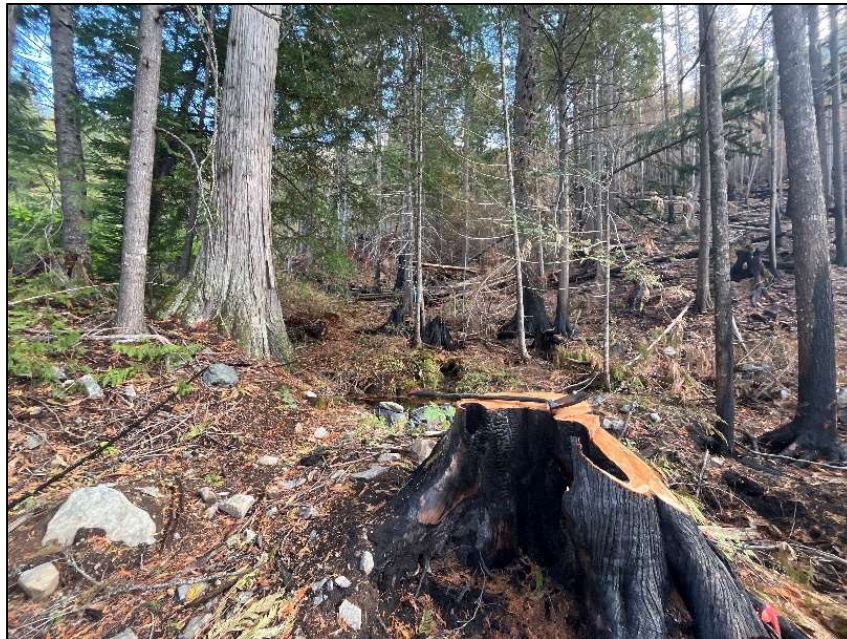
**Photo 23:** View upslope along Highland View Creek at Field Observation Site K17. A small water intake is located in the base of the draw. The upslope channel is small and contained within a well defined draw. Downslope the creek crosses across a broad mid-slope alluvial fan above the Highway.

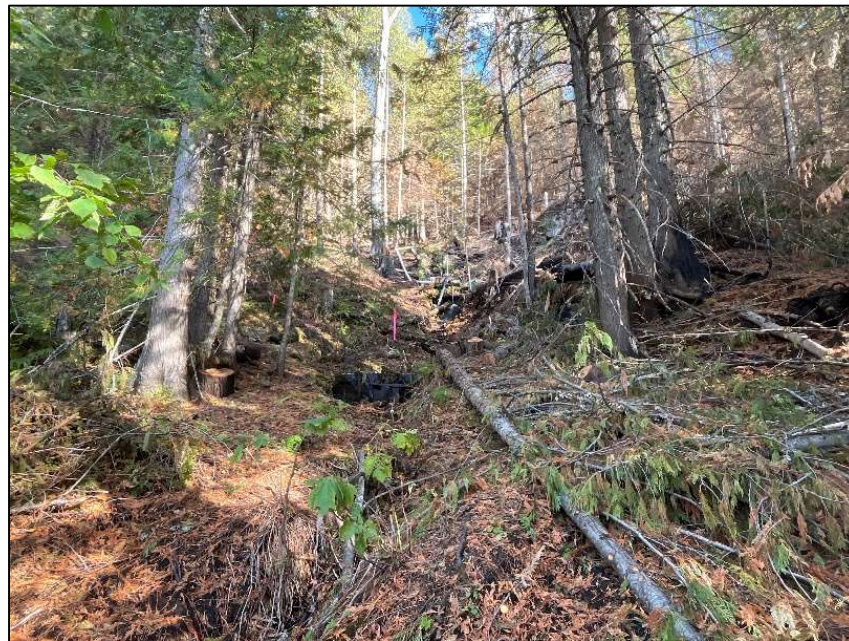
**Photo 25:** View upslope along Kegel Brook at Field Observation Site K24. This creek is small and flows within a well defined draw which leads on to a short steep alluvial fan above the Highway.

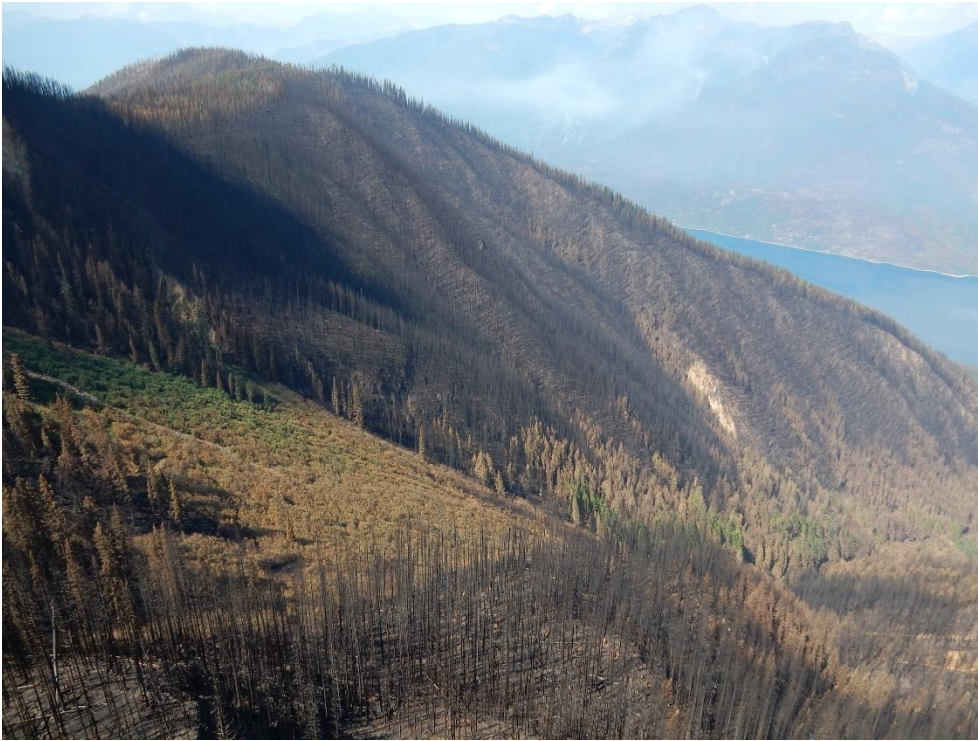
*Figure 4. Photo of high burn severity in the Aylwin Creek watershed.*

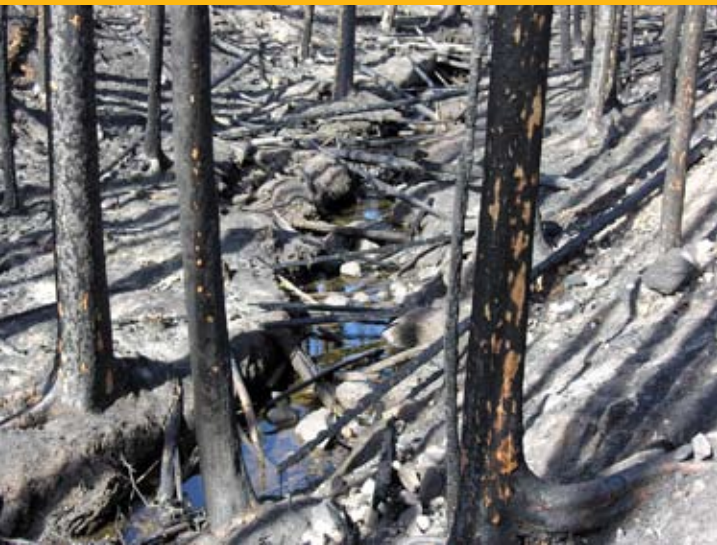
Shorts Creek drainage, burned by 2009 Terrace Mountain fire.

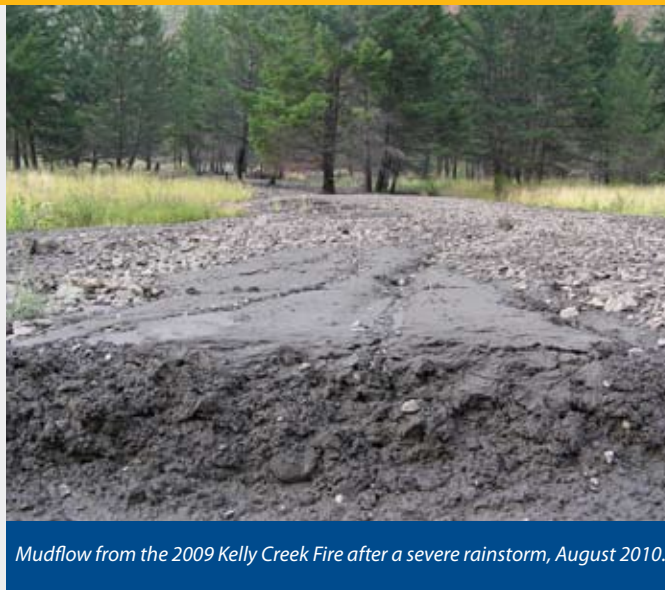
Mudflow from the 2009 Kelly Creek Fire after a severe rainstorm, August 2010.

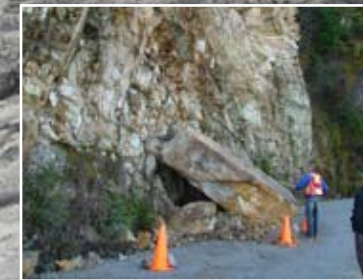
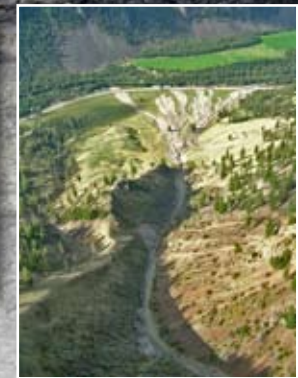
Kuskonook landslide near Creston, BC. This large debris flow occurred during a localized rainstorm on the night of August 6–7, 2004. The heavy rain caused rapid runoff in the headwaters of Kuskonook Creek, in an area burned by a severe wildfire the previous summer.
