BARTLETT CREEK HYDROGEOMORPHIC ASSESSMENT

APEX FILE (HA-18-PR-01)

Prepared for:
Hillary Elliott
Chief Administrative Officer
The Village of Silverton
P.O. Box 14, Silverton, BC, V0G 2B0.

July 13, 2018

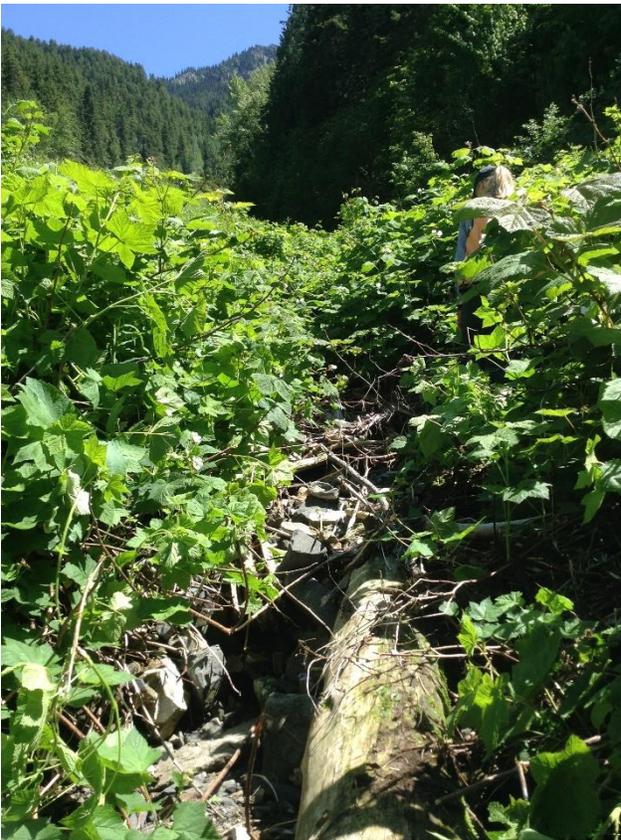
PHOTO 1. LOOKING UPSTREAM AT COLLUVIAL CHANNEL AT B1.

At the time of the field inspection (June 18th, 2018) the headwater channel was dry. At sites B1 and B3 the Bartlett Creek headwater is a single-thread channel that is confined in a v-shaped gully. Evidence was noted of relatively high flows this past spring that created some scour of channel banks.

At sites B1 and B3 Bartlett Creek is a woody-debris step to colluvial channel with an average bankfull width of about 2 metres and an average bankfull depth of 0.16 metres. Angular bedload sediment

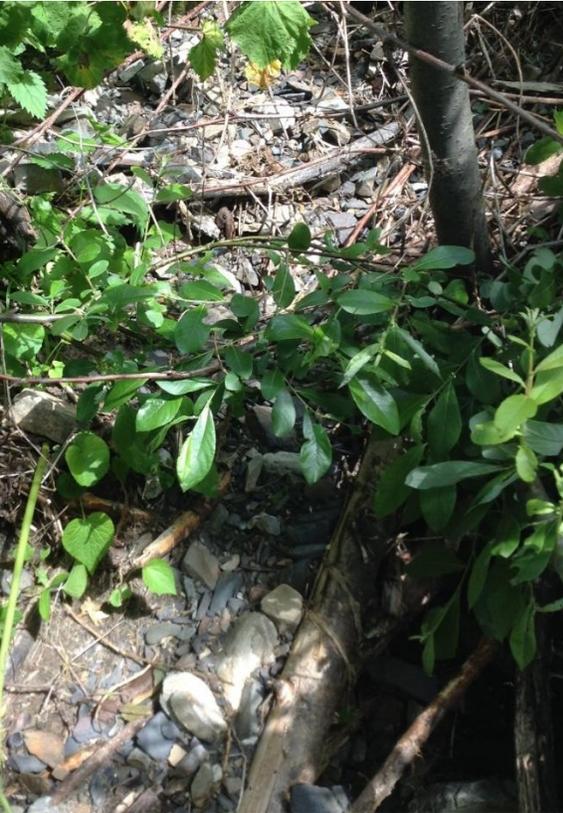
consisting of primarily sedimentary rock has an average D₉₀ (i.e. 90% of the bedload is smaller than this diameter) of 17 cm. Channel gradient above B1 is over 30% but drops to less than 20% at B3 which corresponds to the proposed road crossing location. Despite the steep channel recent debris levees were not evident indicating this headwater reach does not carry debris flows with any frequency.

PHOTO 2. ANGULAR COBBLE SIZED SEDIMENT UP TO ABOUT 17 CM IS MOBILE THROUGH THE HEADWATER OF BARTLETT CREEK.

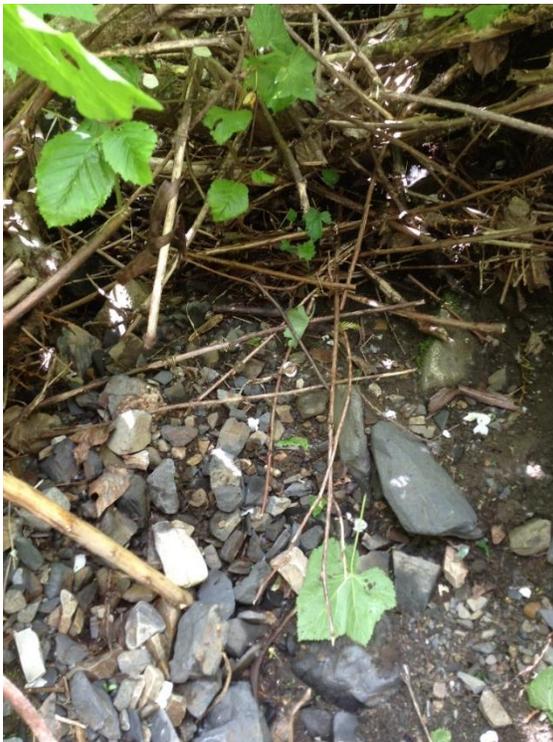
A channel observation site at station B6 (Figure 8) indicates that even at this low elevation on the downslope portion of the depositional fan the eastern headwater tributary was fully dry with no evidence of seepage.

PHOTO 3. THE APPEARANCE OF THE DRY CHANNEL AT THE BOTTOM OF THE EASTERN TRIBUTARY AT SITE B6

The eastern tributary at an elevation of 1000 metres has a similar small woody-debris step morphology that was observed at site B1 and B3. The maximum mobile bed material at site B6 is also similar in size to the bed load noted further upstream although at this point there is more fine gravel being transported. Site B6 also displayed bank scour and recent erosion associated with high flows that occurred this past spring (Photo 3). Immediately upstream from site B6 the channel gradient is approximately 10% to 15%.

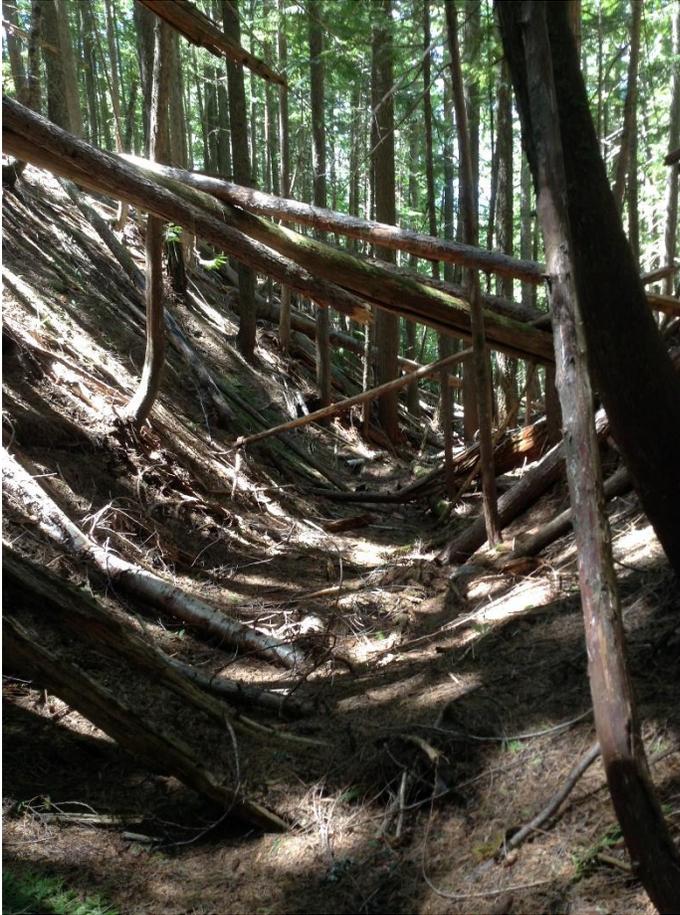
PHOTO 4. LOOKING UPSTREAM AT B2. VEGETATION AND THE ACCUMULATION OF DEBRIS INDICATES THAT THIS GULLY DOES NOT CARRY SURFACE FLOW AT ANY TIME DURING THE YEAR.

The smaller headwater tributary of Bartlett Creek directly north and parallel to the main eastern headwater tributary was observed at sites B2 and B9. At site B2 this well defined gully displays no indicators of carrying surface flow. A very decomposed accumulation of woody debris indicates that this gully carried a debris flow or debris avalanche at least 75 years ago and likely over 100 years ago. At site B9 where a branch of this gully ends at Hartney Flats the base of the gully shows some evidence of

surface flow that mobilized small organic debris including coniferous needles and very small branches.

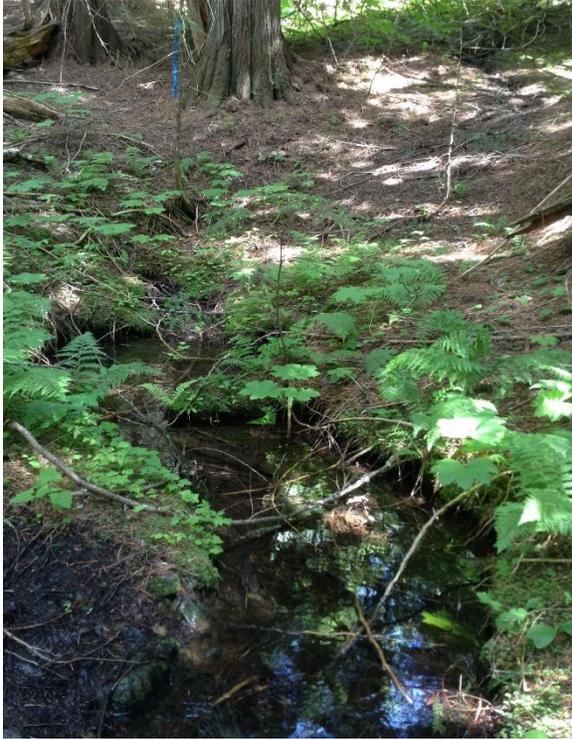
A number of springs occur at the elevation of Hartney Flats. At site B4 (Figure 8) and a second site (B10) about 30 metres north of B4 springs emerge from the forest floor. These springs are topographically higher than the base of the gully at site B9 suggesting that they are not sourced by runoff in the gully. The spring at site B4 has mossy banks and channel bed and appears to have constant flow with limited seasonal flow variability. The spring at B10 is smaller and emerges from the ground on an old mining road.

PHOTO 5. SPRING AT B4 EMERGING FROM FOREST FLOOR.

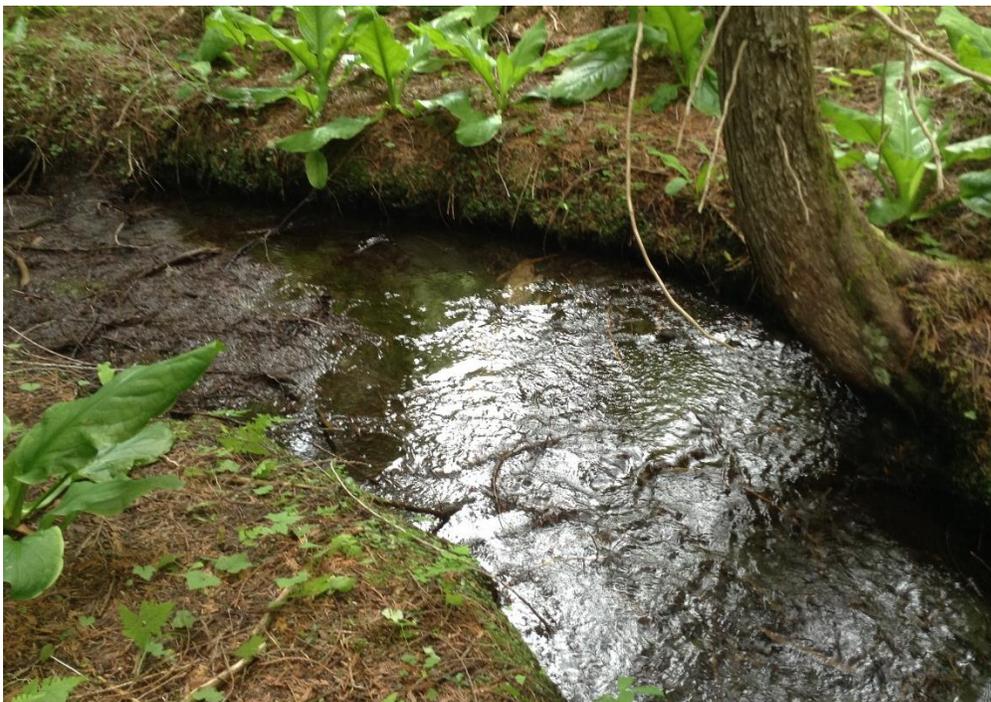
A larger spring flows south along Hartney Flats and is referred to in this assessment as the north fork headwater of Bartlett Creek. The confluence of the north fork with B4 spring occurs at an elevation of about 1000 metres elevation. A second field session was undertaken to determine the source area of the north fork of Bartlett Creek. Sites B11 to B20 on Figure 8 trace the location of this perennial spring. At several locations along the course of the main channel including sites B13, B16 and B18 additional springs enter the main channel

from the eastern slopes of Hartney flats. Upstream from site B16 the north fork channel becomes intermittent and flows subsurface for some stretches (Photo 6).

PHOTO 6. NORTH FORK CHANNEL AT SITE B16. CHANNEL IS INTERMITTENT (FLOWING BENEATH THE FOREST FLOOR) UPSTREAM FROM THIS POINT.

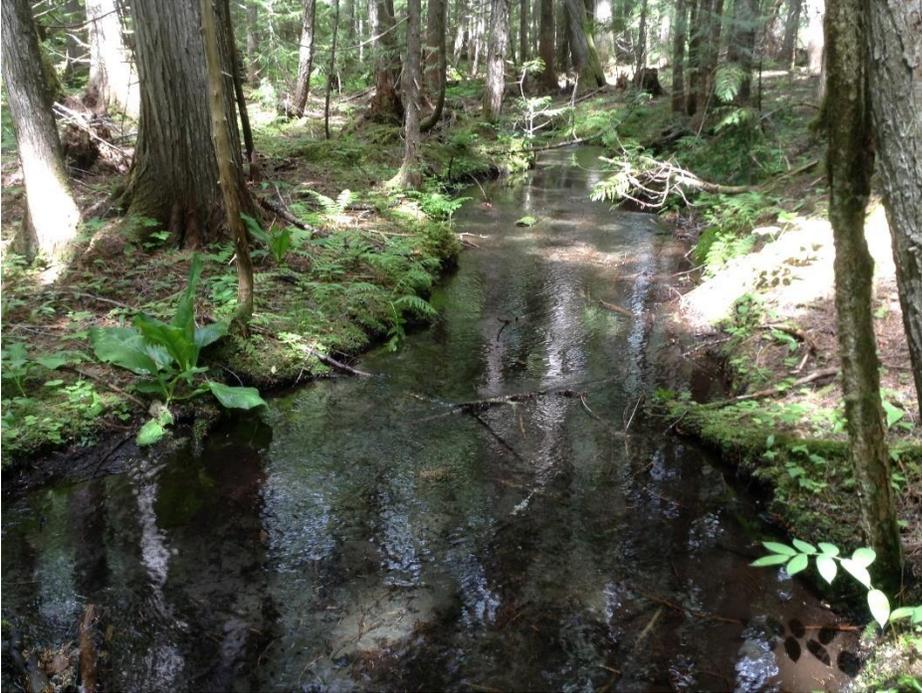
PHOTO 7. LOOKING UPSTREAM AT SITE B14 ON BARTLETT NORTH FORK.

For most of the length of the north fork of Bartlett Creek, the channel is a low gradient (<2%) riffle-pool channel with a bedload limited to fine gravel, sand and organic muck. Channel banks are overhanging and vegetated with mosses. Some recent bank scour above the current flow stage noted in locations along the length of this channel indicates that there is some seasonal flow variation associated with the spring freshet. The scour appears to be from the 2018 freshet. Channel bankfull width and depth is generally invariant along the length of the north fork channel ranging from 1.7 metres to 1.85 metres as the surface catchment area increases from 45 hectares to 99 hectares.

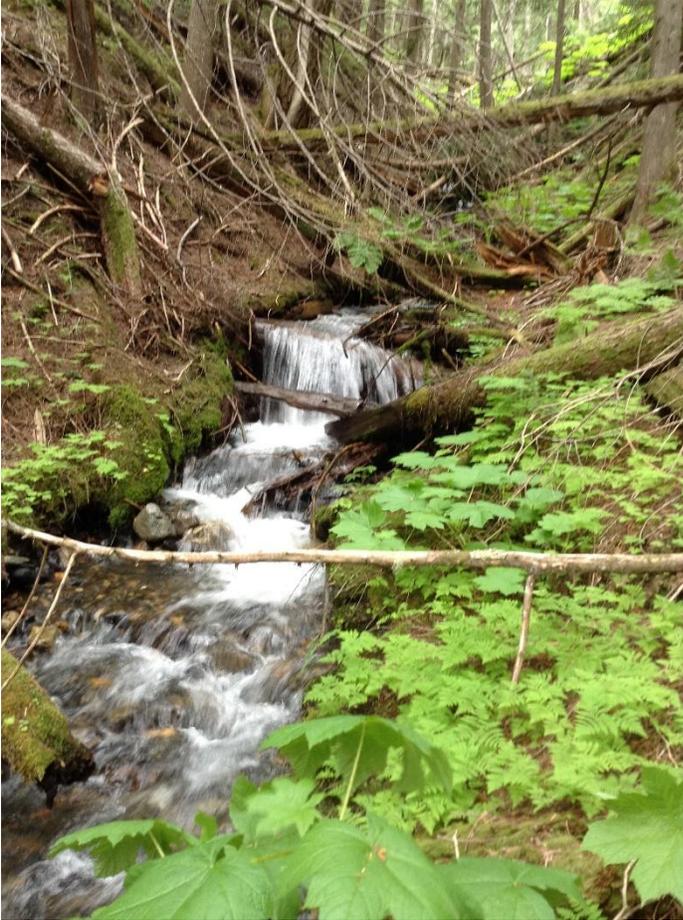
PHOTO 8. LOOKING UPSTREAM AT BARTLETT CREEK AT SITE B7.

Below Hartney flats Bartlett Creek is contained in a steep-sided (~80%) valley underlain by glacial sediments. The channel has a gradient of 28% and a forced step morphology with single pieces of large woody debris distributed along the channel forming steps. Channel banks are vegetated and overhanging. The bedload sediment is relatively fine grained and consists primarily of subrounded small cobble to gravel. The D90 through this section are subrounded cobbles with a diameter of about 15 cm.

Woody debris forming steps in the channel and spanning the channel appears to have been in place for at least 50 years or more. This observation along with well vegetated flood deposits noted along the channel margins downstream from B7 suggest that the last major channel forming flood in this portion of Barrett Creek occurred at least 50 to 75 years ago. Some recent scour along upper channel banks indicates that the 2018 flood was a larger than average flood event. Small woody debris including the branches less than about 1cm diameter were mobilized in the 2018 flood but none of the larger elements in the channel appear to have been disturbed.

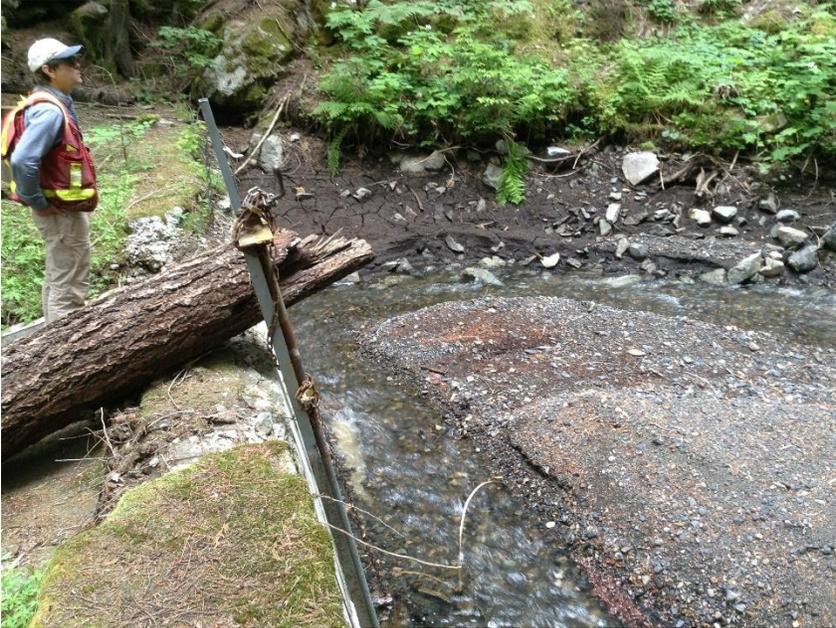
PHOTO 9. THE DAM ON BARTLETT CREEK AT B8. THE LARGER THAN AVERAGE PEAK FLOW IN 2018 HAS DEPOSITED A WEDGE OF SMALL COBBLE TO ORGANIC MUD WHICH IS TRAPPED BEHIND THE DAM.

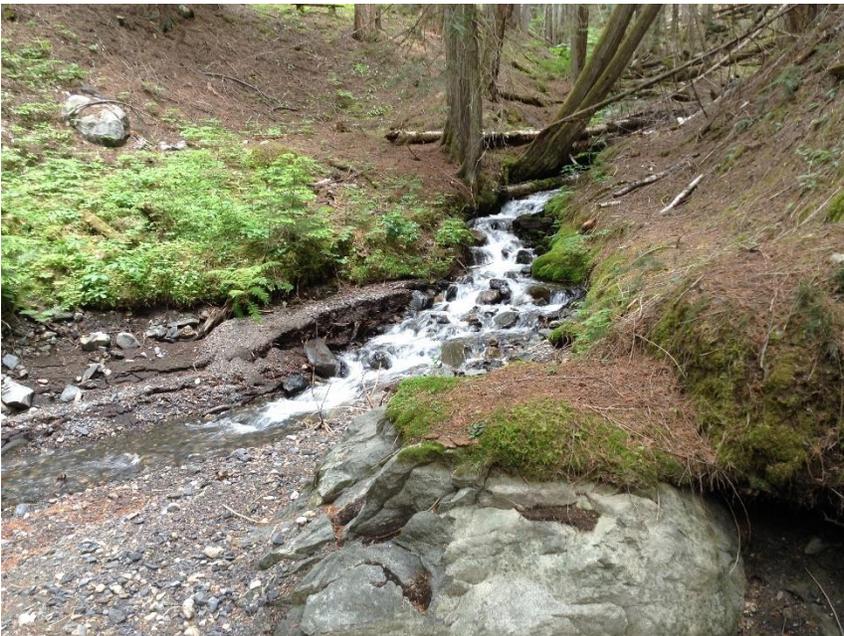
PHOTO 10. LOOKING UPSTREAM ABOVE THE DAM AT BARTLETT CREEK. BEDROCK EXPOSED AT THE DAM IS INTRUSIVE GRANODIORITE.

Bartlett Creek upstream from the dam has a cobble and woody debris step pool morphology. Abundant old woody debris spanning the channel suggests that the last channel forming flood occurred at least 50 years ago. Channel banks are generally overhanging and vegetated. There

has been a substantial amount of disturbance to the riparian area along this section of Bartlett Creek which makes it difficult to assess the disturbance history.

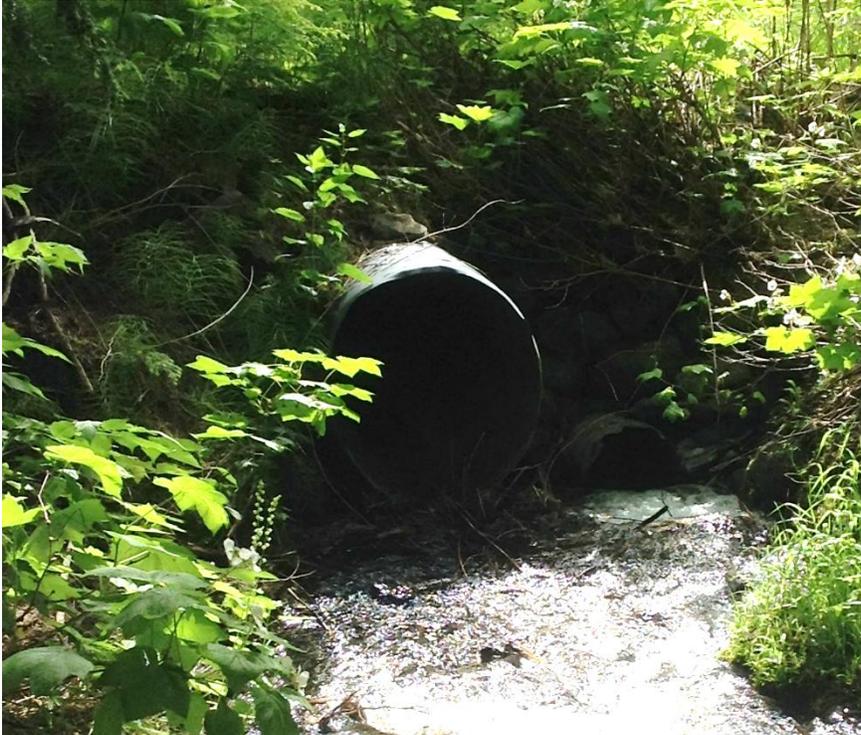
At the Standard Road crossing Bartlett Creek is carried in two culverts with diameters of 850mm and a 600mm (Photo 11). The culvert inlet and road ditchline display no obvious indicators of erosion which suggests they are sufficiently sized.

PHOTO 11. BARTLETT CREEK AT STANDARD ROAD. TWO CULVERTS (850MM AND 600MM) APPEAR TO HAVE MANAGED FLOWS ON BARTLETT CREEK WITHOUT INCIDENT FOR AT LEAST SEVERAL DECADES .
